Monitoring Completed Navigation Projects Program

Periodic Inspection of Ofu Harbor Breakwater, American Samoa

Armor Unit Monitoring for Period 1996-2002

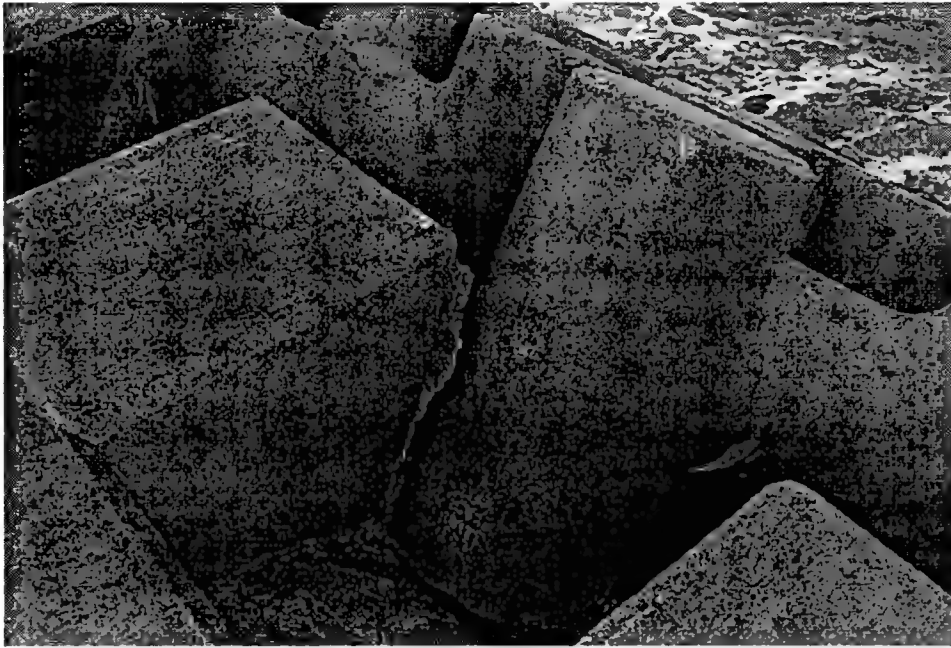
On 22 May 2002, a walking survey of above-water armor units was conducted on the outer 132.6-m (435-ft) portion of the Ofu Harbor breakwater. The survey of the structure revealed no broken tribars. Fifteen sea-side tribars were slightly separated from the rib cap (Figure 11). These separations ranged from 0.64 to 7.62 cm (0.25 to 3 in) and occurred on ribs 2, 12, 13, 14, 16, 20, 22, 25, 26, 32, 39, 42, 66, 67, and 71 (beginning with ribs at the shoreward end). Only one separation was noted during the previous survey at rib 22 (sta 3+07). On the entire sea-side of the structure it also was noted that some of the “Swiss cheese block” underlayer units had separated along the slope between the third and fourth rows (down from the crest). Typical separations ranged from 2.54 to 10.16 cm (1 to 4 in.), and the maximum was about 20.32 cm (8 in.). Some separations were predominantly vertical (Figure 12) while others were predominantly horizontal (Figure 13). Separations of about 2.54 to 10.16 cm (1 to 4 in.), both horizontally and vertically were also noted on “cheese blocks” on the harbor side of the structure. Separations between the “cheese block” underlayer units appeared to be more widespread during this inspection as opposed to the previous one. The geotextile bags had deteriorated and some spalling along the edges of the 510-kg (1,125-lb) high-strength concrete underlayer units was also noted around the head of the structure (Figure 14). These conditions were also noted during the previous inspection. Some slight movement in the breakwater’s underlayer armor units has occurred, but in general, the breakwater appeared to be in excellent condition.

Figure 11. Separation between tribar and rib cap

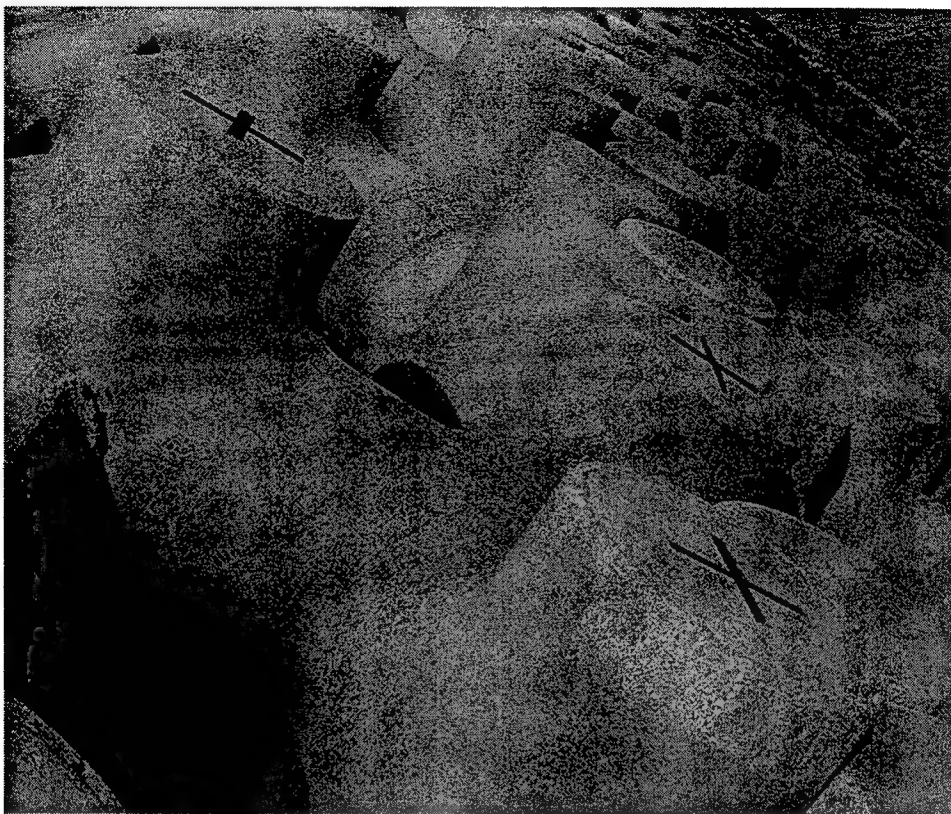
In addition, targets were re-established on selected concrete armor units. As previously reported (Bottin and Boc 1997), a total of 33 tribars was selected for detailed study. They represent an even distribution throughout the tribar field, and occupy positions ranging from near the waterline to close to the rib cap at the crest of the structure. These armor units (tribars 101-133) were painted with three targets (Figure 16). The target for each tribar is indicated by an A, B, or C. Three targets on an individual tribar allow for very precise measurements depicting individual armor unit movement. Twenty additional tribars (units 19-38) were painted with a single target to serve as photogrammetric control points, as well as to be used to detect armor unit movement during future ground surveys. A 0.64-cm (1/4-in.) hole was drilled at the center of each target to mark the survey points for subsequent surveys. Units were chosen for targeting that had flat surfaces close to horizontal to maximize their visibility in aerial photography and allow for accurate representation of armor unit movement. Locations of the targeted tribars are shown in Figures 17 and 18.

Figure 16. View of a targeted tribar (three targets established)
